**CORROSION FORMS AND CONSERVATION TREATMENTS OF
THE ATHENA (MINERVA) STATUE OF THE ATHENS ACADEMY -
GREECE**

V. LAMPROPOULOS et alii

**CONSERVATION AND
RESTORATION OF THE
ARCHAEOLOGICAL SITE OF
KOTZIA SQUARE, ATHENS -
GREECE**

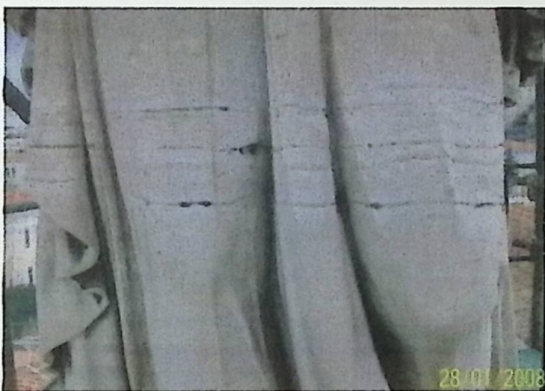
- "Carbonisation" of the surface areas that are exposed to rainwater.
- Sulfation in surface areas that are not exposed to rainwater.
- Cracks - fractures - discontinuities of marble caused by the oxidation and inflation of iron contacts, as well as from the mineralogical heterogeneity of marble (discontinuities of marble and mechanic strain e.g. earthquakes) (Fig. 4).
- Wetting and exfoliation have occurred in areas where the marble presents decreased cohesion, infiltration and withholding of increasing quantity of water.
- Deposition of particles - black crust is located in areas that remain protected from rainwater causing undesirable aesthetic effects. This phenomenon is mainly observed in areas where the

Fig. 4 Cracks due to the mineralogical heterogeneity of the marble.

After removing the remains of silicone from previous interventions, sealing was done all over the surface of the statue⁸, at the places that cracks and micro-cracks had been located. At the column and the column capital, sealing of cracks was done with mortar of the same constitution.

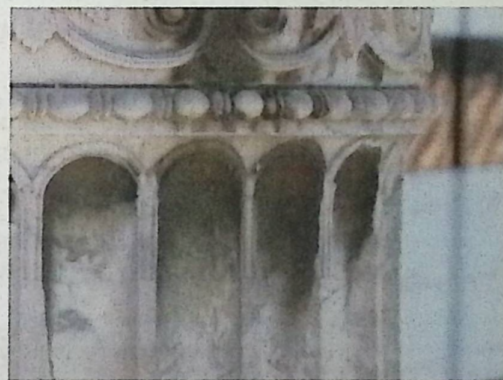
marble surface has deteriorated and the porosity has increased, which results in hovering particles penetrating more easily the material (Fig. 5).

Fig. 5. Deposition of particles.

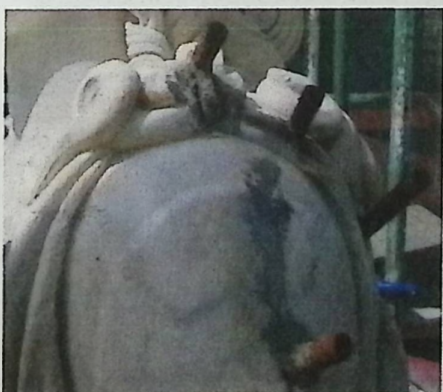
- Previous conservation interventions. These were observed in the cracks and in the discontinuities of the marble, which had been sealed with silicone. Moreover, in previous attempts of strengthening the support of the shield, grey cement and iron elements had been used, as seen in Fig. 6. What is more, it is likely that the manner of support of the spear had been altered by introducing a metal joining, which had been fixed on the cloak of the sculpture.

Fig. 6. Previous intervention for the support of the shield using grey cement and iron elements.

The shield was packed with bubble wrap and was transported to the Academy where it was placed again on the sculpture with the help of a crane. More concretely, the five support pins that retained the shield on the statue, and the grey cement that used to hold them in place, were replaced with brass pins and were fixed on the statue with mortar⁴.

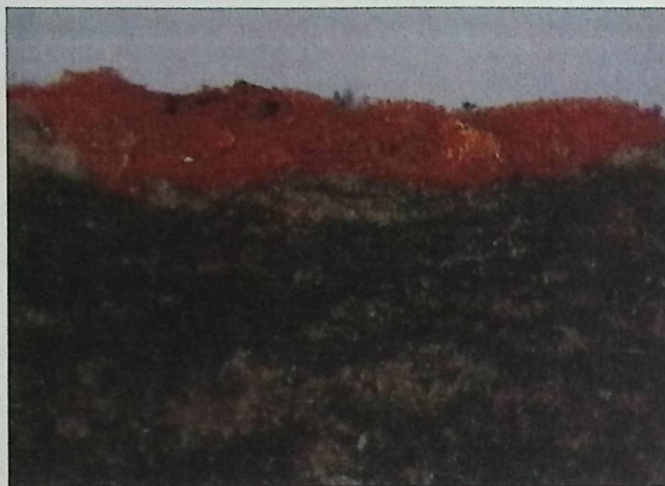
Fig. 7. Magnification 4,5 in point of sample 1.

Observations: It is iron with calcium depositions (most likely the product of iron oxidation) and phosphor (most likely from excrements of birds) in points.

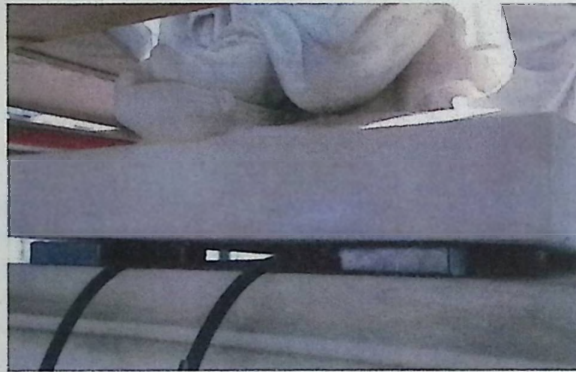
- The results of vibrations. There has been dislocation of the statue and its base. The main cause of this phenomenon was the vibrations resulting from sounds, noises and earthquakes. The greatest deterioration has been caused by seismic vibrations (locomotion and intensity of cracking).

Afterwards a metal frame was manufactured and placed around the upper part of the column capital, where a piston was installed for the locomotion of the statue. A slight elevation was achieved with the use of a screw gear (Fig. 8), while suitable gentle pressing was applied with the use of a piston, supported in the metal frame, near each edge of the base. The process was repeated three times until the desirable result had been achieved.

Fig. 8. Elevation of base with the use of screw gears.

This intervention aimed at the restoration of resistance of the base and the replacement of corroded elements. Screw gears, aiming at the elevation of base, were used for the replacement of iron wedges, with lead- invested stainless steel of the same dimensions.

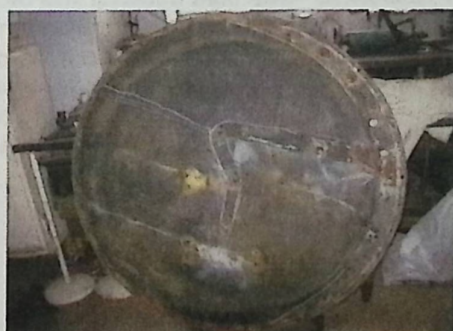
Fig. 11. The back side of the shield before cleaning.

37 iron dowels, with a diameter of 10 mm each, were removed in the laboratory. These dowels had been placed at a distance of 12 cm from each other. 7 more dowels, of a 12 mm diameter, were also removed³. The iron hoop, which is the support of the cross arms that was found at the back of the shield, was also removed (Fig. 11), as was the head of Medusa from the front side of the shield. After these removals, cleaning was performed at the points where the iron elements existed and at the back side of the head of Medusa. The cleaning of the surface from dust and dissolved products of erosion was done using solvent of acetone. The cleaning was followed by the replacement of the iron elements with brassy elements of corresponding dimensions (Fig. 12), with the exception of the new brass dowels that were all of a 15 mm diameter. Afterwards, the head of Medusa was fixed in its original place on the shield. This was followed by the process of protection of the metal surface with microcrystalline wax b-square 193. Lastly, and as part of the aesthetic restoration, in order to minimise the shine of the new brass elements, the pieces were covered with a solution of artificial oxidation for copper which creates black patina.

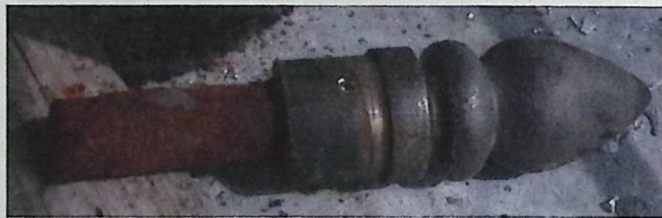
The spear is constituted by two cupreous parts: the forward and back part. These were probably screwed in an iron contact which is found in the right hand of the statue and connects the marble with the spear. Initially, it was attempted to abstract the shield in two parts. This was rendered impossible, as there was great danger of fracturing the marble of the statue. Afterwards, the iron support of the lower part of the spear was removed, which was replaced with bronze and was fixed with mortar⁵. Also, the iron counterpoise from the back part of spear was removed (Fig. 13) and was also replaced. The new counterpoise is bronze and cast in mould.

Fig. 13. The iron counterweight.

The spear was cleaned mechanically with Dremel and a bronze brush. Artificial patina was applied on the surface of the brassy and bronze elements, for both aesthetics reasons and the protection of copper.

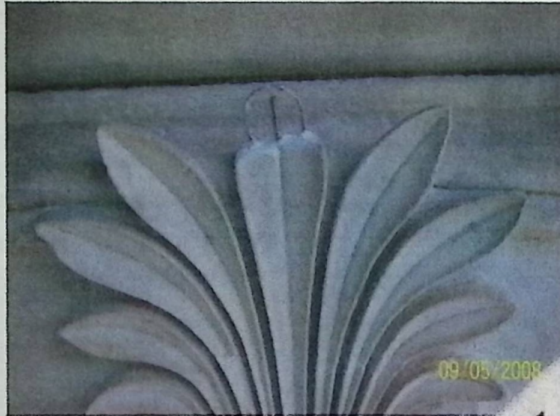
The anthemion on the eastern aspect presented loss of material at the top, which was most likely owed to the oxidation and expansion of the iron contact. The corroded metal element was removed, whereas two more holes were opened. In the central hole, a ribbed titanium bar of 6 mm diameter was inserted; the other two holes were filled with a non ribbed titanium bar in the form of a petal, of 3 mm diameter (Fig. 16). The titanium bars were fixed with white cement, which was pressed into the holes as grout before their insertion. At the end, the completion of the anthemion was done with mortar of the same constitution.

Fig. 16. Ribbed titanium bars and bar in petal shape, fixed with mortar.

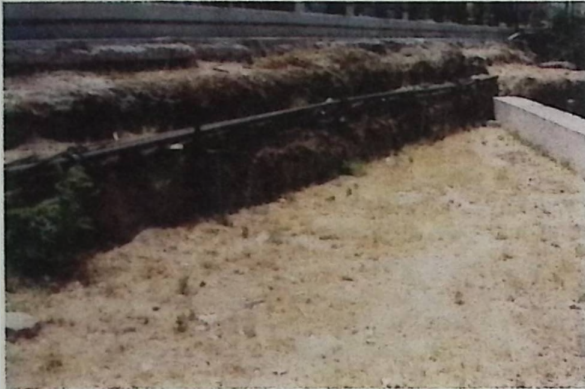
Fig. 1. The archaeological site before conservation.

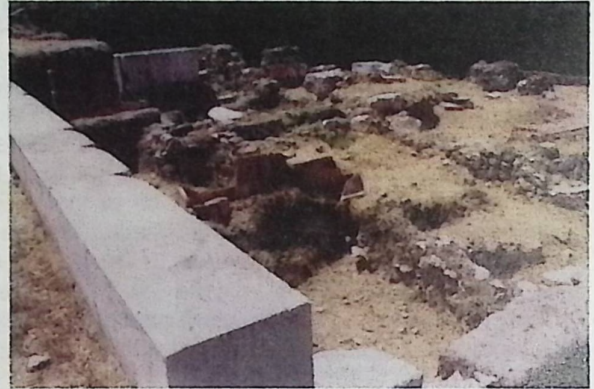
Fig. 2. The archaeological site before conservation.

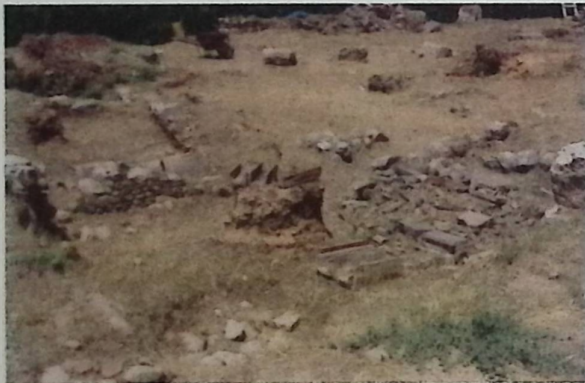
Fig. 3. The archaeological site before conservation.
