CONSERVATION AND RESTORATION OF THE ACADEMY OF ATHENS – GREECE

THE BRONZE STATUE OF EVANGELOS AVEROF – TOSSITSAS IN METSOVO - GREECE. CORROSION PATTERNS AND CONSERVATION PROCEDURES

THE BRONZE STATUE OF EVANGELOS AVEROF - TOSSITSAS IN METSOVO - GREECE. CORROSION PATTERNS AND CONSERVA- TION PROCEDURES

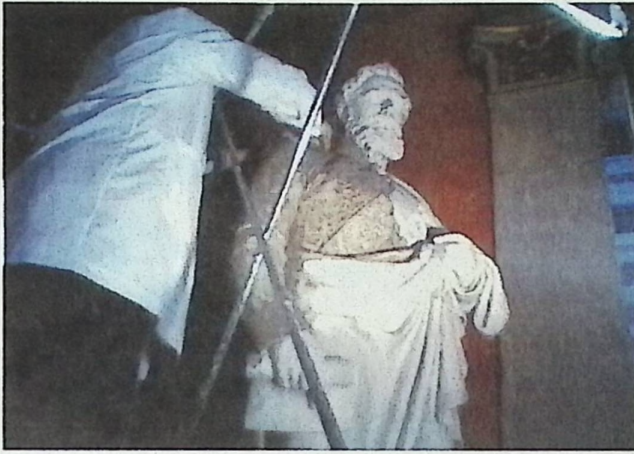
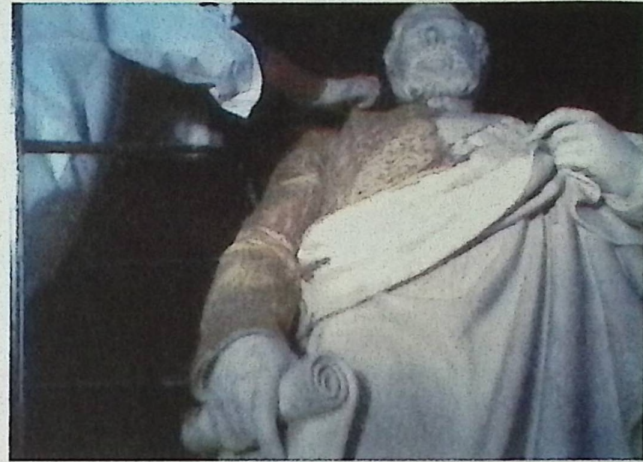
Fig. 5. The marble statue of Simon Sinas during the conservation procedure (cleaning by use of absorbent clays - sepiolite).

Fig. 6. The marble statue of Simon Sinas during the conservation procedure (cleaning by use of absorbent clays - sepiolite).

In particular, the stage of cleaning and repair was carried out with non-ionic water and surfactants, paste of Mora and adsorbent clay, in order to clean and remove the resilient crust of the surface. The result was the desirable one, as we measured the pH and the specific electrical conductivity of the washed areas, and we confirmed the removal of all the oxide and alkaline reactivity.

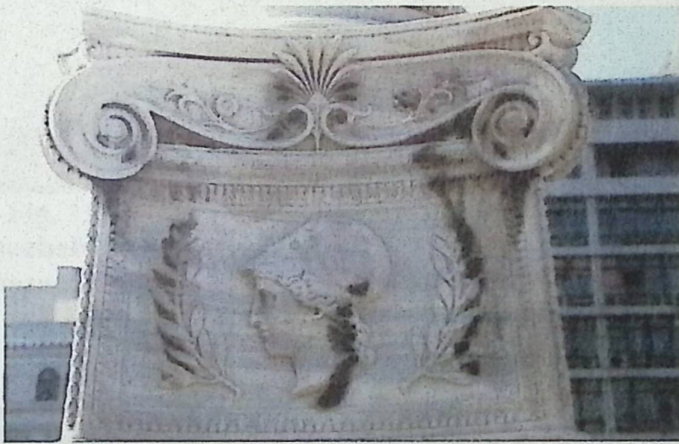
Fig. 7. Marble statue of light column before the conservation procedure (presence of black crust due to the atmospheric pollution).

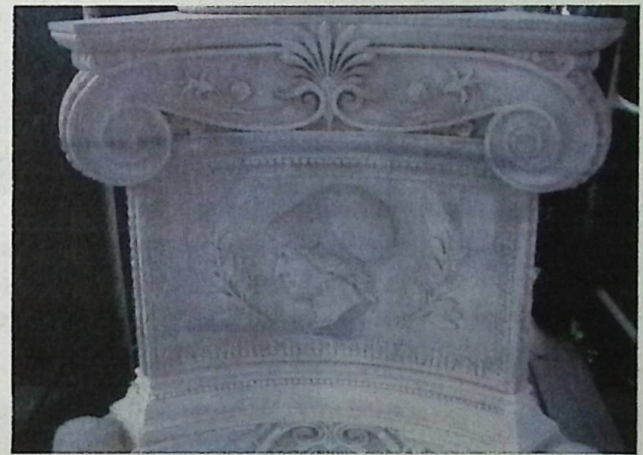
Fig. 8. Marble statue of light column after the conservation procedure.

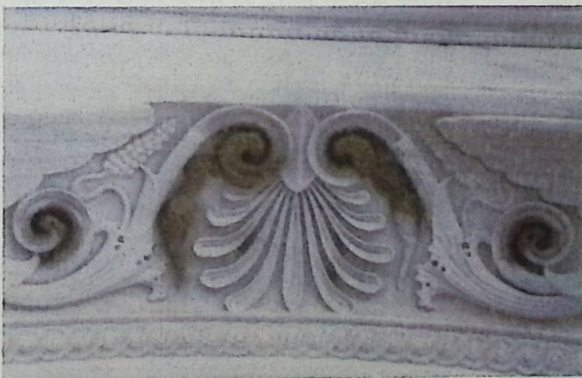
Fig. 9. Marble statue of light column before the conservation procedure (cleaning by use of absorbent clays - sepiolite).

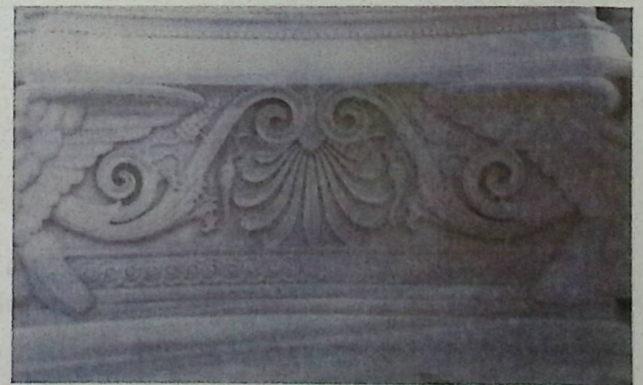
Fig. 10. Marble statue of light column after the conservation procedure.

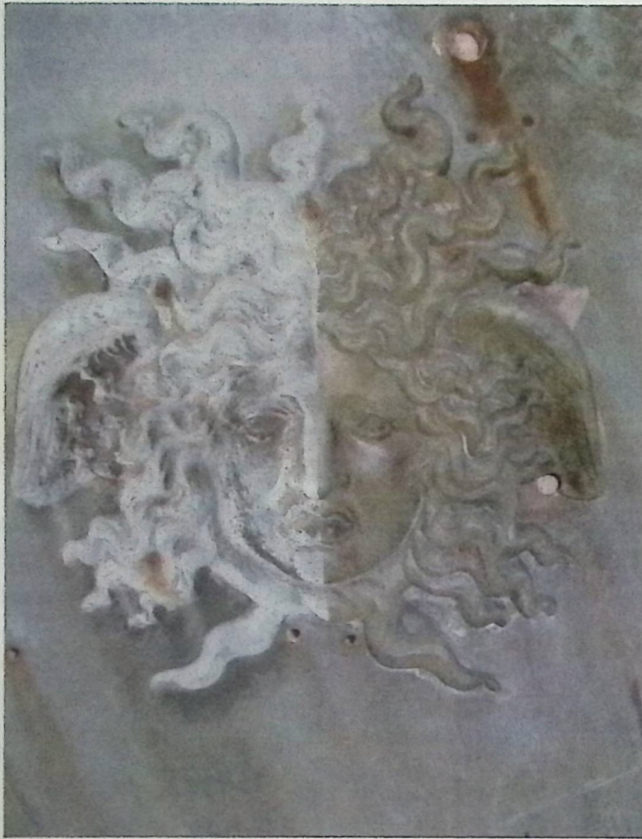
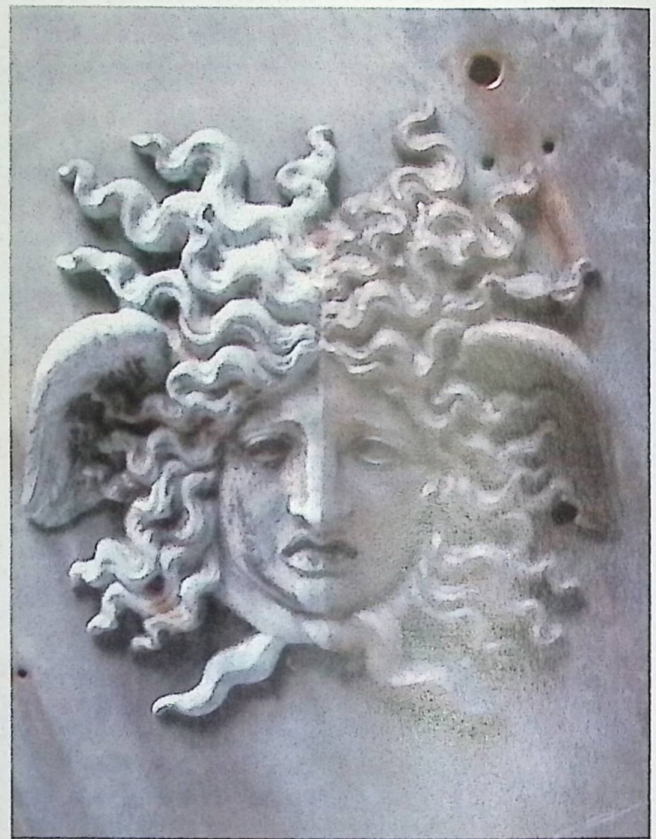
Fig. 11. The bronze statue of Medusa on the statue of Minerva during the conservation procedure (cleaning by use of mechanical methods).

Fig. 12. The bronze statue of Medusa on the statue of Minerva during the conservation procedure.

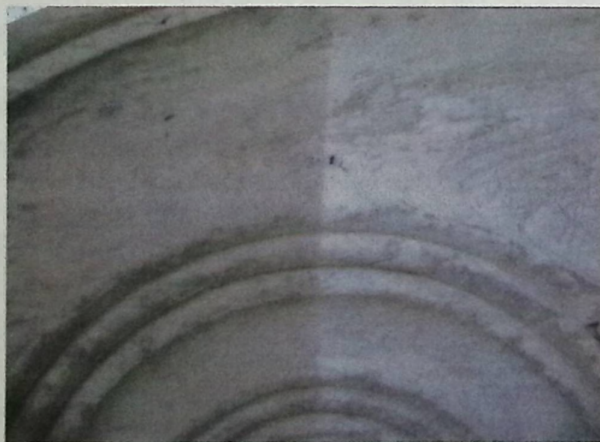
Fig. 13. The marble statue of Apollo during the conservation procedure (presence of acid rain effect).

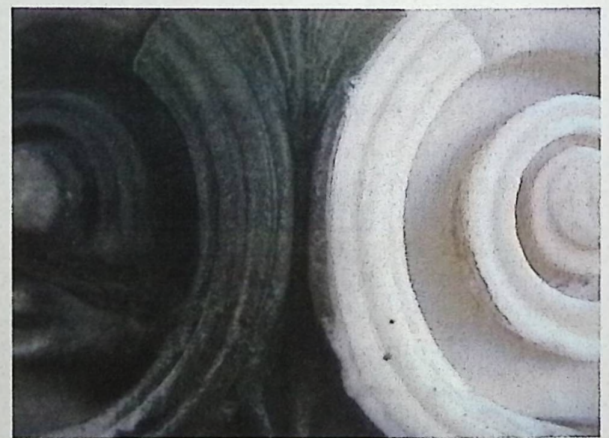
Fig. 14. The marble statue of Apollo during the conservation procedure (presence of black crust due to atmospheric pollution).

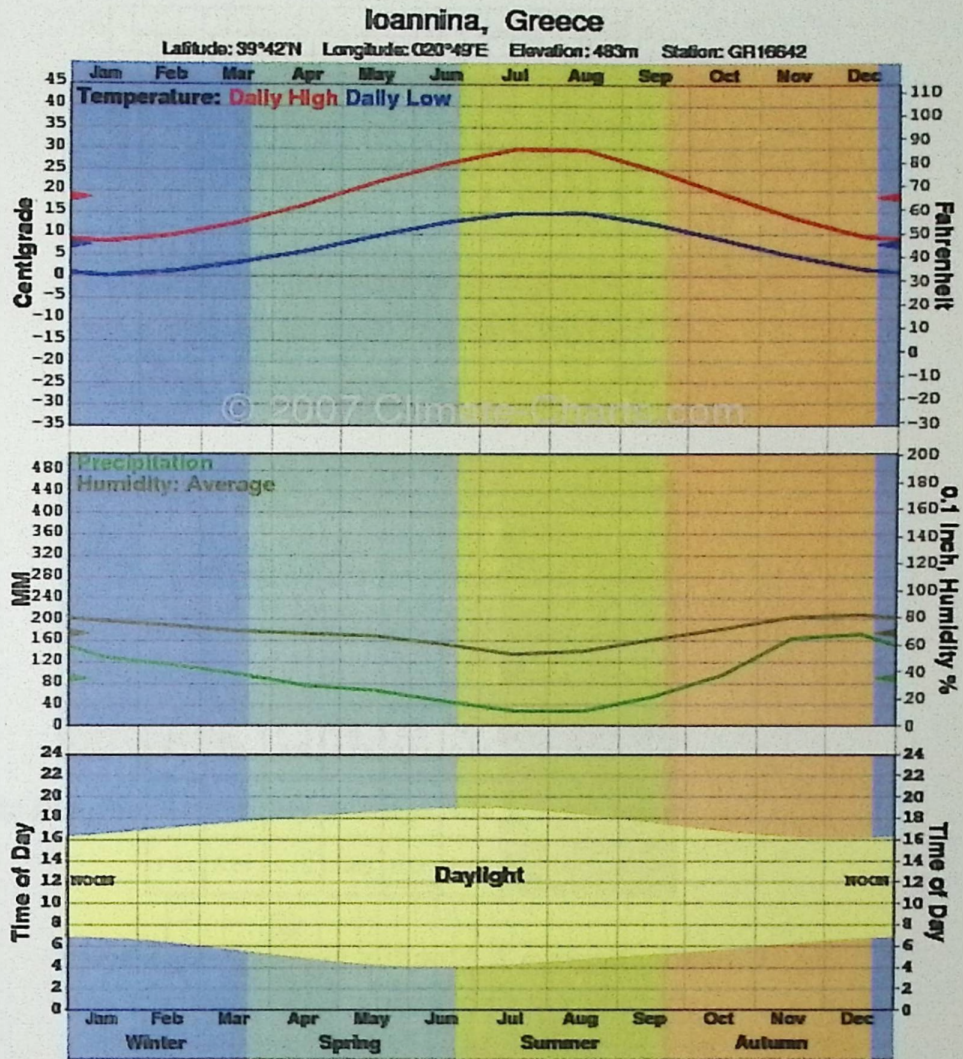
Climatic Diagram 1. Ioannina Greece Yearly Climate Temperature and Precipitation. Ioannina: Longitude 20°49'1" / Latitude 39°42'0" / Alt 483m.

At the top section, high and low temperatures are shown with red and blue lines respectively. In the middle section, precipitation is in green and humidity in brown. At the bottom section, daylight is shown by the yellow area with a time-of-day scale on both sides.

Additionally, according to the above climatic diagrams it is obvious that the climate is humid and rainy with cold, long and dry winters and warm summers with few local rains. Particularly, intense snowfalls are marked from December to March and frosts are observed from November until April. It is marked that January is the coldest month of the year while the hottest is July.

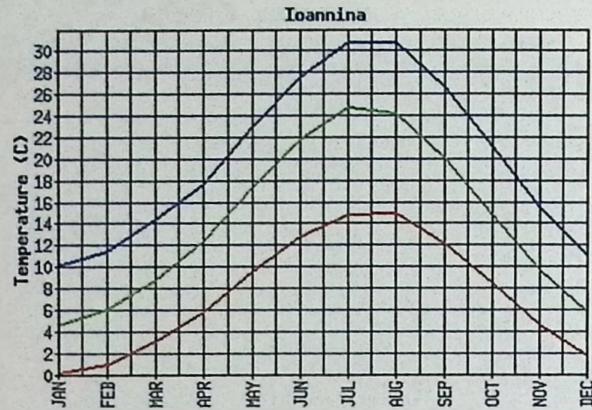
Climatic Diagram 2. Monthly average temperature.

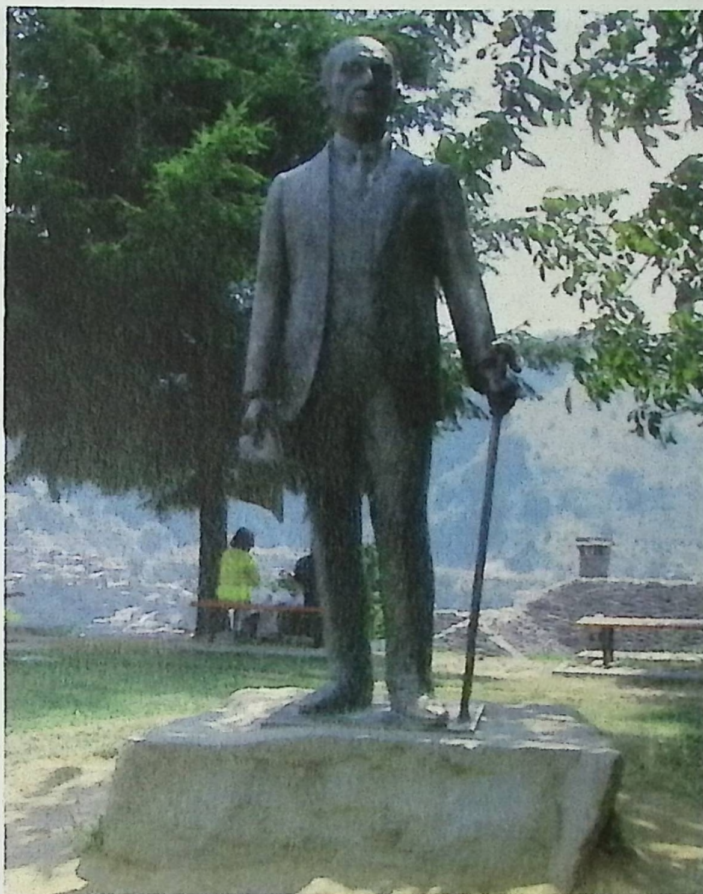
Fig. 7. The bronze statue of Evangelos Averof-Tossitsas in Metsovo.

This bronze statue is located in the middle of the public park in Metsovo. Given the rapid adjustment of the metal surface to the temperature of the surrounding air, the factors of precipitation and high relative humidity are the fundamental elements that accelerate electrochemical corrosion. In regard to the electrochemical aspects, climate certainly has a decisive influence on the corrosion of the bronze. Fundamentally, it must be said that humidity, temperature and different atmospheric polluting agents of this region constitute its “macroclimate”, whereas the “microclimate” is the specific condition surrounding the object, depending surely on the sculpture’s morphology. Copper and bronze objects or elements of construction, such as sculptures, are affected by the atmospheric environment. Thus, the surface of a bronze statue is covered with corrosion products, dirt and biological contamination.

Samples from this sculpture mainly contained copper corrosion and patina compounds. A mineral analysis with the use of X-rays diffraction (X.R.D.) and Scanning Electron Microscope (S.E.M.) has been performed in order to estimate the corrosion materials and the depositions. Gypsum ($\text{CaSO}_4 \cdot 2\text{H}_2\text{O}$) and Descloizite ($\text{Pb}(\text{Zn}, \text{Cu})\text{VO}_4(\text{OH})$) have been formed on the base of its surface as confirmed by X-Ray Diffraction (X.R.D.) analysis. The more abundant corrosion products identified on the whole surface are Rozazite of zinc ($\text{Cu}, \text{Zn})_2\text{CO}_3(\text{OH})_2$, Rozazite ($\text{Cu}, \text{Zn}(\text{CO}_3(\text{OH})_2)$, Cuprite (Cu_2O), Moganite (SiO_2), Paratacamite ($\text{Cu}_2\text{Cl}(\text{OH})_3$), Clinocllore ($\text{CuPb}_2\text{Cl}_2(\text{OH})_4$).

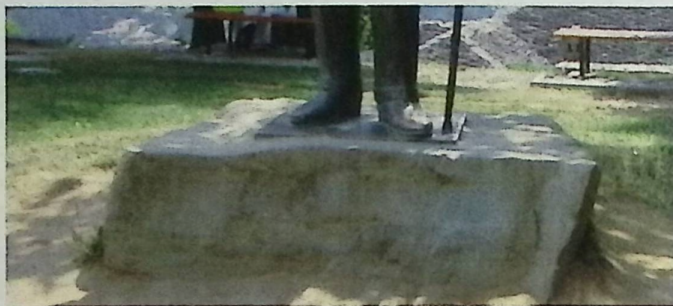
Fig. 8. The base of the statue.

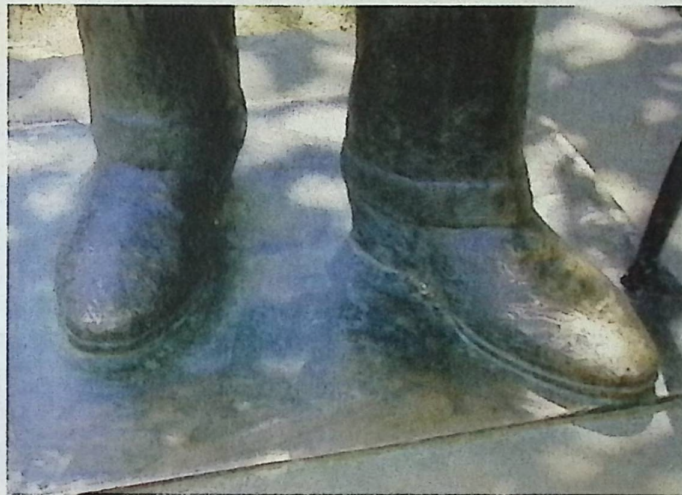
The sculpture also suffered a natural alteration due to the instability of bronze in outdoor conditions. In fact, it presents major problems of natural corrosion such as the removal of the protective layer (wax) and the development of corrosion materials in specific areas of its surface. Thus, the alteration is present in the form of a heavy corrosion on the surface exposed to streaming water and to moisture. The hands, the legs and the feet of the statue are corroded because of the actions of visitors that caused the disappearance of the original patina.

Fig. 9. Removal of "patina" on feet of the statue.

The most appropriate methods used in conservation for the cleaning of statuary are laser cleaning, abrasive cleaning, chemical cleaning and steam cleaning. In practice, the surface of the statue was cleaned with a mixture of organic solvents which were very active on the paint without any influence on the patina, in the cases of corroded wax and graffiti. In addition, deionized water, chelated agents (E.D.T.A.) and mechanical methods were used for the cases of biological depositions and corrosion materials. Using high pressure water technology in order to treat the whole surface, it is possible to maintain colour continuity. After this cleaning, no significant areas of active corrosion were found. It is certain that all these cleaning treatments make the monument more aesthetically pleasing and at the same time can reveal some unresolved conservation problems.

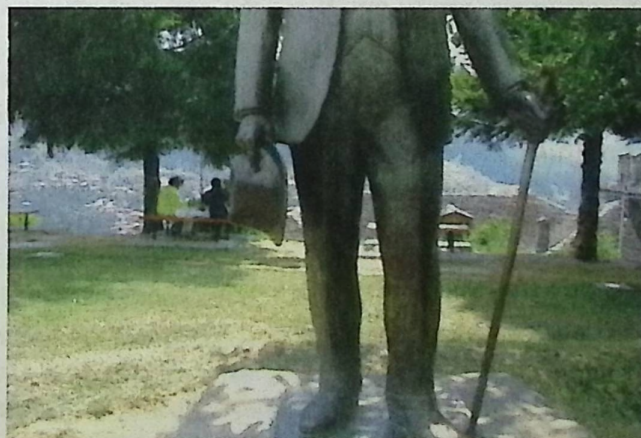
Fig. 10. Removal of the protective layer (wax) and appearance of corrosion materials.

Consequently, this outdoor bronze has lost its original artificial patina and its surface coating. The surface of the bronze has developed a natural, green patina with heavy black copper sulphide because of the lack of maintenance. On the whole surface of this statue there is also a thin green layer of mineral "malachite" as a result of the corrosive environment. Furthermore, there is "graffiti" in the form of symbols and various figures at the back of the statue.

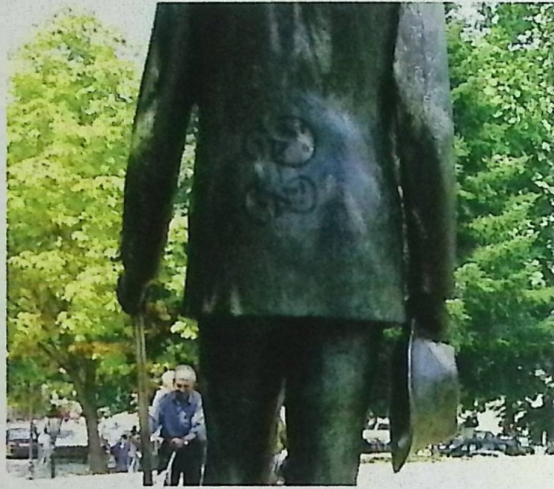
Fig. 11. Presence of graffiti on the surface of the statue.

Its popularity as a tourist attraction also leads to significant wear to the accessible areas of the sculpture, and to the attention of graffiti artists. As a result, the surface of the bronze sculpture is in poor condition, mainly because of surface dirt and discolouration. It deteriorates over time and also loses its characteristic brightness.

In fact, this sculpture is in some ways a living object and will always be touched. This reflects the fact that new graffiti will reappear. The metal surface can be protected by the wax and in that case the graffiti should be easily eliminated. As a general rule, we recommend a new application of wax every two or five years in order to keep its efficiency and also to clean the freshly made graffiti. Similarly, given the need to seal the surface from moisture, it is necessary to apply an impermeable arrangement of coatings. The key to the long-term protection for bronzes is regular maintenance and the renewal of protective coatings of lacquer or waxes. Actually, the high resistance of copper to atmospheric corrosion and the characteristic layers of corrosion products (patina) contribute to greater stability of objects in the atmospheric environment.
