**CORROSION FORMS AND CONSERVATION TREATMENTS OF
THE ATHENA (MINERVA) STATUE OF THE ATHENS ACADEMY -
GREECE**

V. LAMPROPOULOS et alii

**CONSERVATION AND
RESTORATION OF THE
ARCHAEOLOGICAL SITE OF
KOTZIA SQUARE, ATHENS -
GREECE**

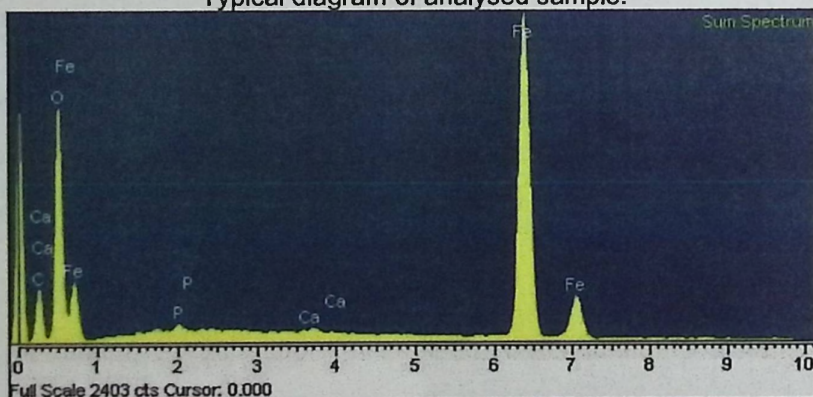
Typical diagram of analysed sample.

Diagram: Element peaks of the sample.

Observations: It is iron with calcium depositions (most likely the product of iron oxidation) and phosphor (most likely from excrements of birds) in points.

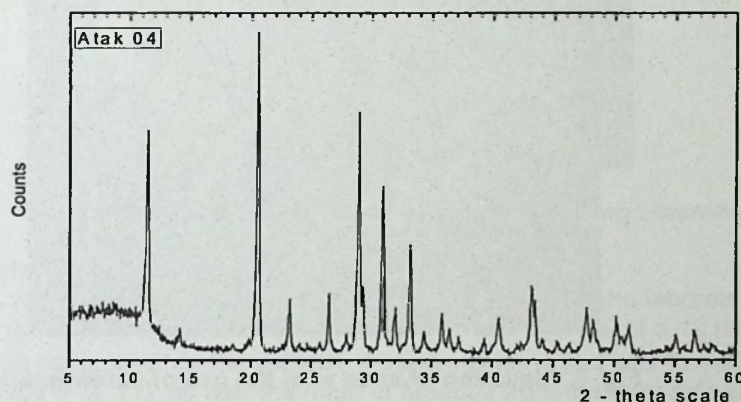
Typical diagram of analysed sample.

The peaks correspond to gypsum (gypsum: 33-311) and the peak in the 140 corresponds to chloride lead (Pb-chloride: 25-434) or chloride calcium (Ca-chloride: 16-119).

Conclusions: The existence of gypsum (it was located in all the 3 samples) confirms the 'Carbonisation' of the marble surface. Tracing of quartz indicates the existence of venations with aluminosilicate components.

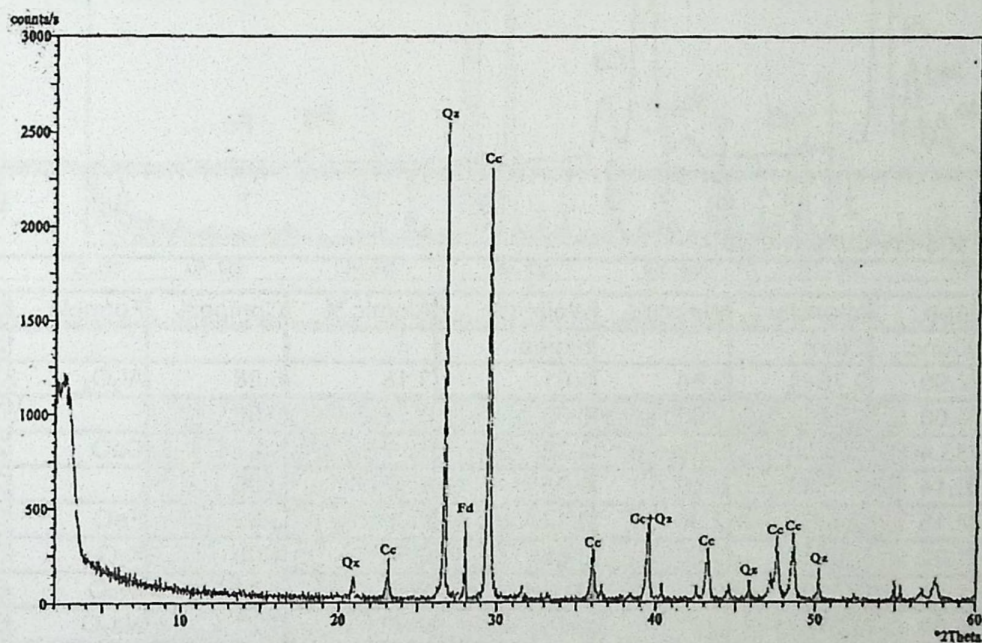
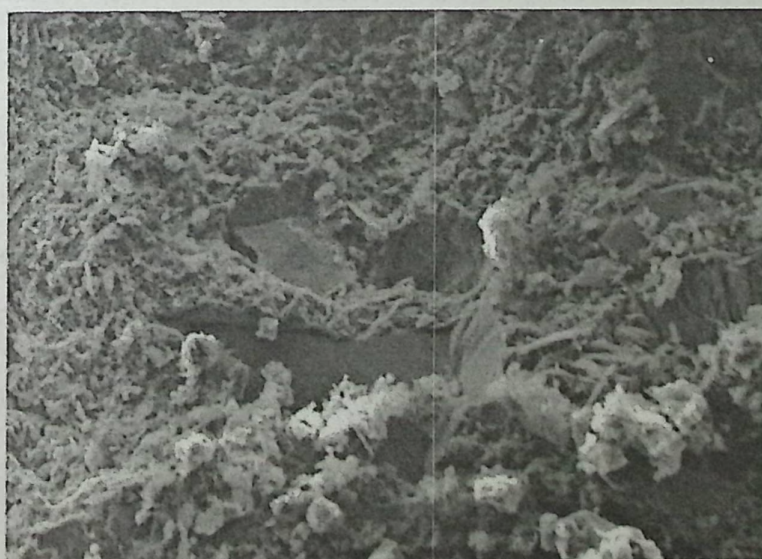
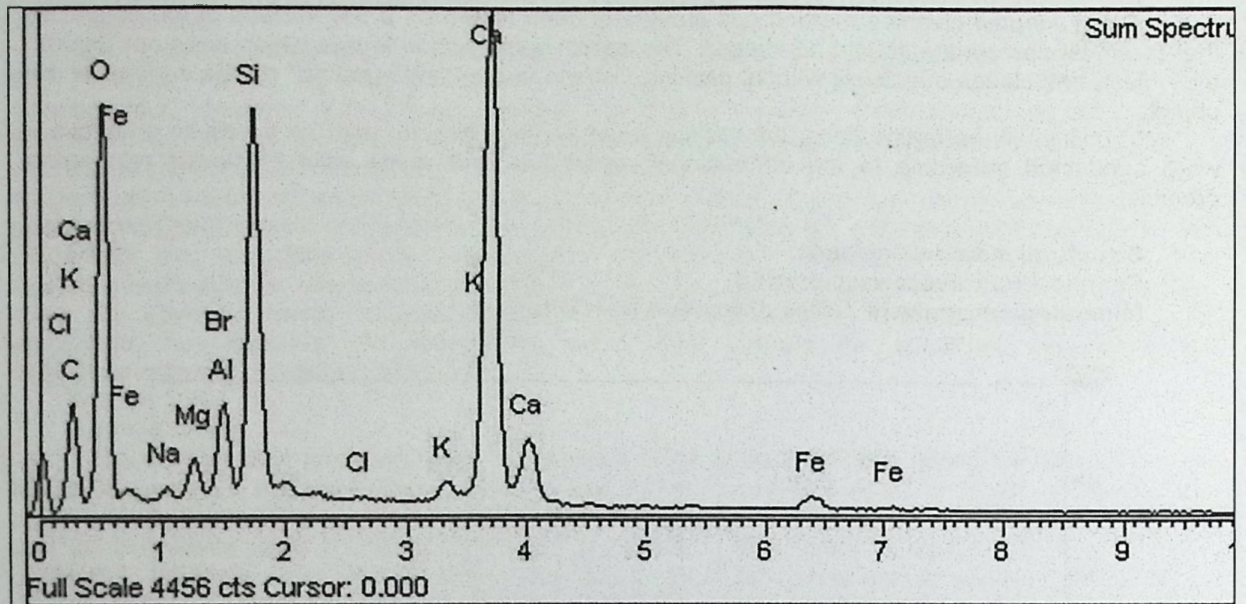
Sample 1 (carnivorowsses mortar).

Element	App	Intensity	Weight%	Weight%	Atomic %	Compd%	Formula	Number
	Conc.	Corrn.		Sigma				of ions
Al K	2.90	0.7544	3.64	0.61	3.18	6.88	Al ₂ O ₃	0.44
Br L	0.00	0.7030	0.00	0.00	0.00	0.00		0.00
Ca K	33.40	0.9897	32.00	0.32	18.79	44.78	CaO	2.59
Cl K	0.14	0.7537	0.18	0.05	0.12	0.00		0.02
Fe K	2.15	0.8136	2.50	0.14	1.06	3.22	FeO	0.15
K K	1.02	1.0798	0.90	0.06	0.54	1.08	K ₂ O	0.07
Mg K	1.54	0.6539	2.24	0.09	2.17	3.71	MgO	0.30
Na K	0.69	0.6764	0.97	0.10	0.99	1.31	Na ₂ O	0.14
Si K	15.68	0.8188	18.16	0.20	15.21	38.84	SiO ₂	2.10
O			39.41	0.47	57.96			7.98
Totals			100.00					
							Cation sum	5.78

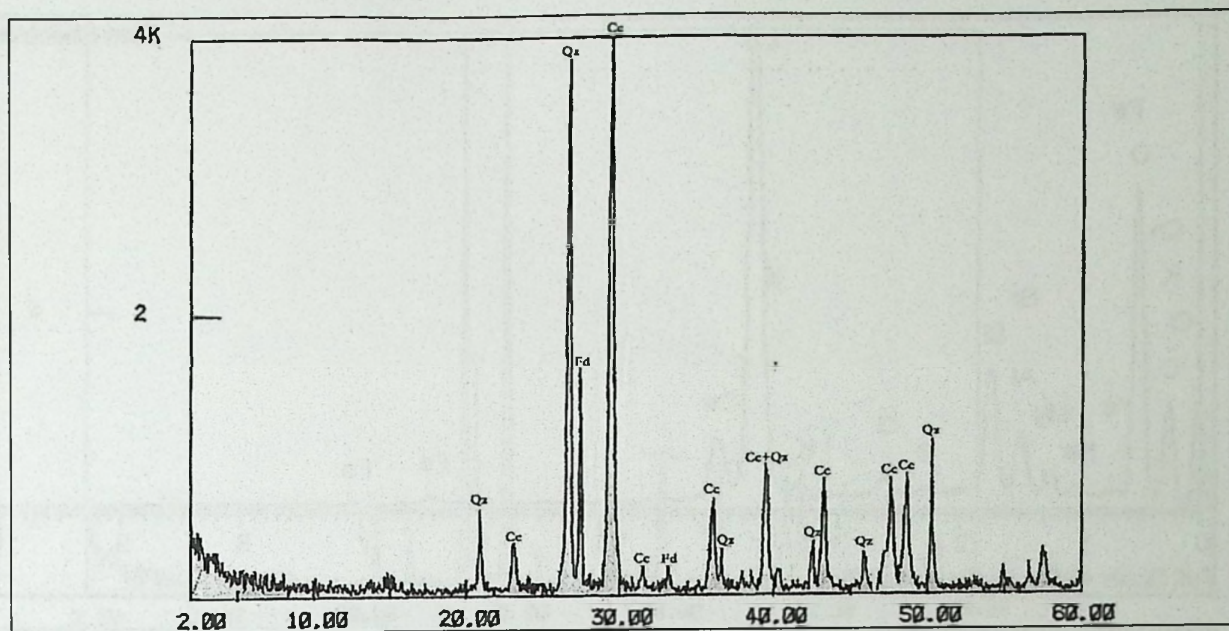
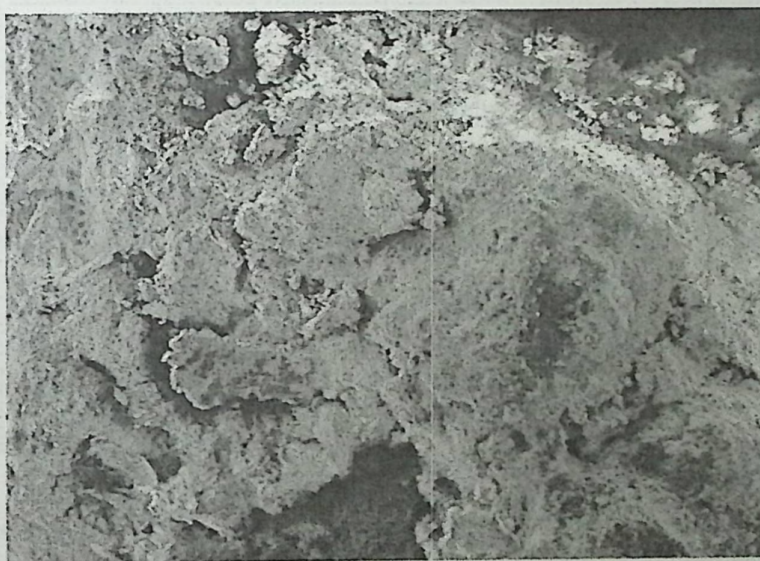
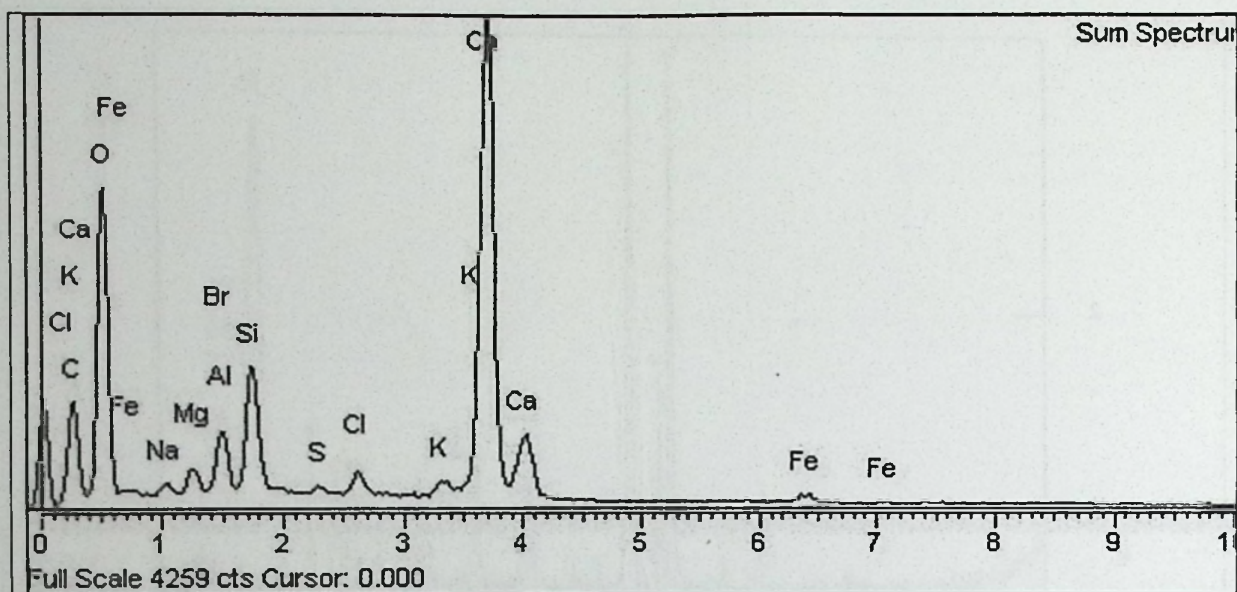
Sample 2 (carnivorowses mortar).

Element	App	Intensity	Weight%	Weight%	Atomic %	Compd%	Formula	Number
	Conc.	Corrn.		Sigma				of ions
Al K	1.64	0.7423	2.39	0.70	2.29	4.51	Al ₂ O ₃	0.33
Br L	2.33	0.6924	3.64	1.39	1.18	0.00		0.17
Ca K	41.43	1.0140	44.12	0.81	28.49	61.73	CaO	4.10
Cl K	1.11	0.7956	1.51	0.08	1.10	0.00		0.16
Fe K	1.42	0.8156	1.87	0.17	0.87	2.41	FeO	0.13
K K	0.93	1.1303	0.89	0.08	0.59	1.07	K ₂ O	0.08
Mg K	1.19	0.6363	2.02	0.11	2.16	3.36	MgO	0.31
Na K	0.84	0.6596	1.37	0.14	1.55	1.85	Na ₂ O	0.22
S K	0.38	0.8624	0.47	0.07	0.38	1.18	SO ₃	0.05
Si K	6.34	0.7818	8.76	0.20	8.08	18.75	SiO ₂	1.16
O			32.95	0.73	53.32			7.67
Totals			100.00					
							Cation sum	6.39

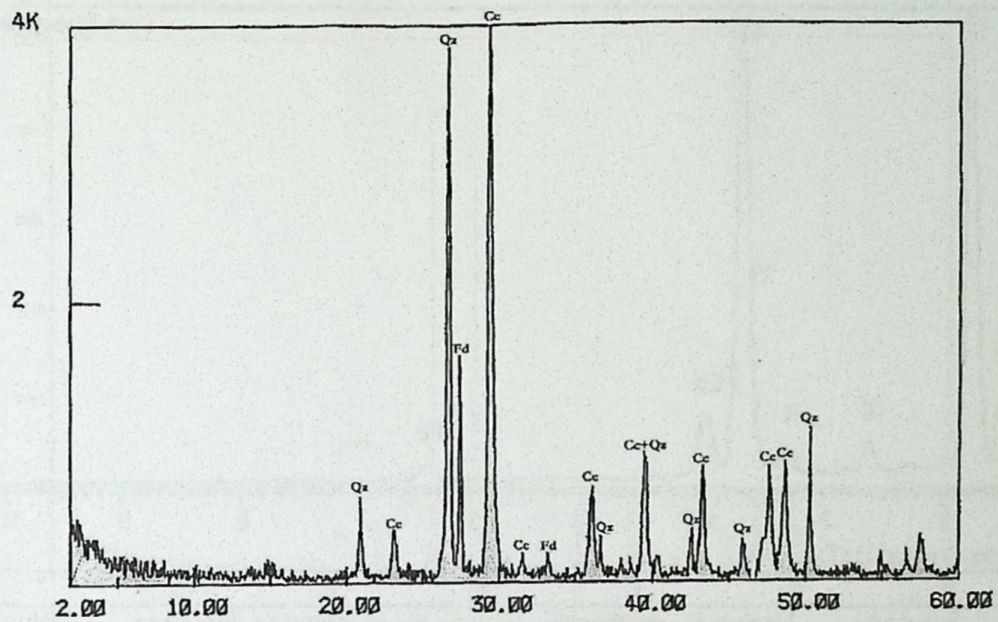
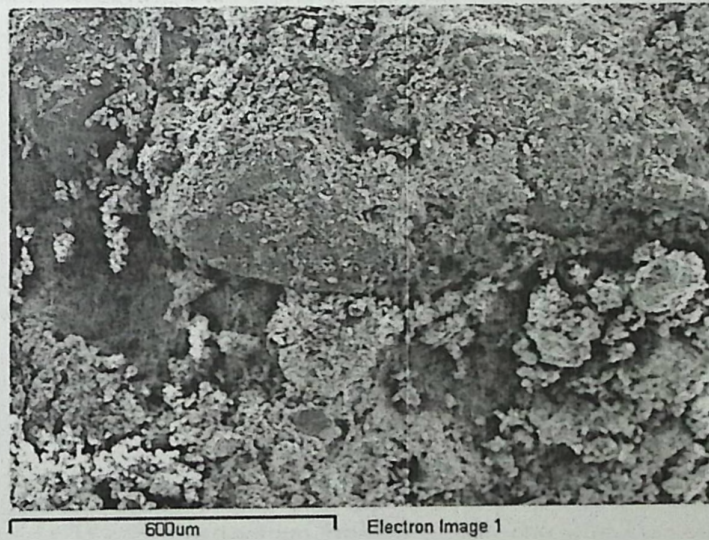
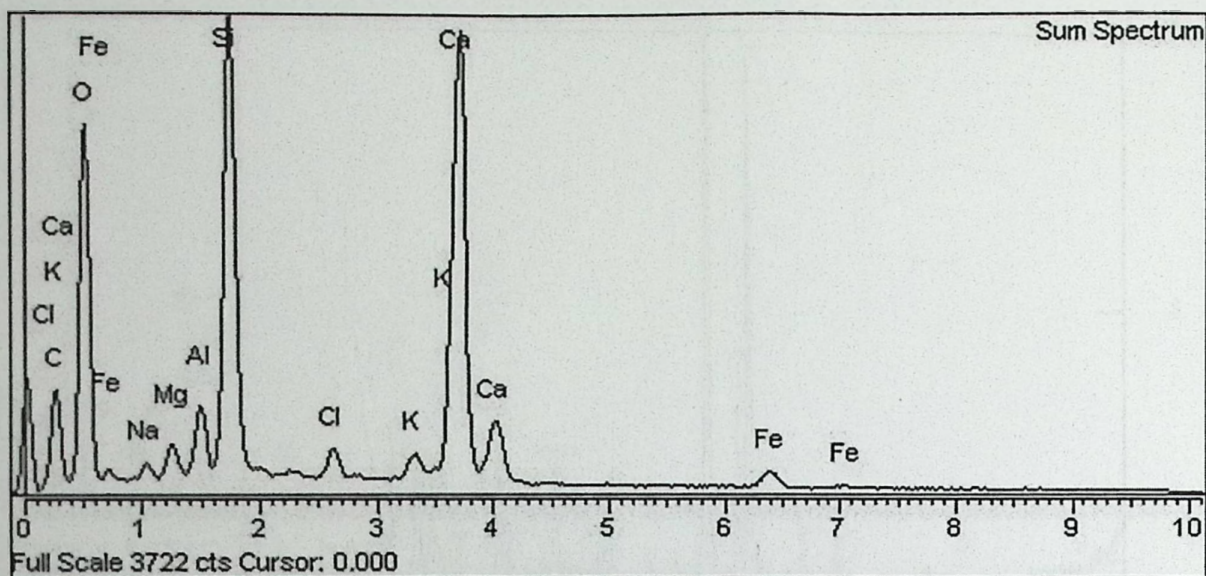
Sample 3 (stone masonry mortar).

Element	App	Intensity	Weight%	Weight%	Atomic %	Compd%	Formula	Number
	Conc.	Corrn.		Sigma				of ions
Al K	2.53	0.7624	3.00	0.08	2.60	5.67	Al ₂ O ₃	0.35
Ca K	31.01	0.9784	28.60	0.17	16.68	40.01	CaO	2.26
Cl K	1.34	0.7461	1.63	0.07	1.07	0.00		0.15
Fe K	2.45	0.8154	2.71	0.15	1.13	3.48	FeO	0.15
K K	1.26	1.0576	1.08	0.07	0.64	1.30	K ₂ O	0.09
Mg K	1.42	0.6585	1.95	0.08	1.87	3.23	MgO	0.25
Na K	0.93	0.6860	1.22	0.10	1.24	1.65	Na ₂ O	0.17
Si K	18.56	0.8321	20.12	0.13	16.75	43.04	SiO ₂	2.27
O			39.71	0.19	58.01			7.85
Totals			100.00					
							Cation sum	5.54

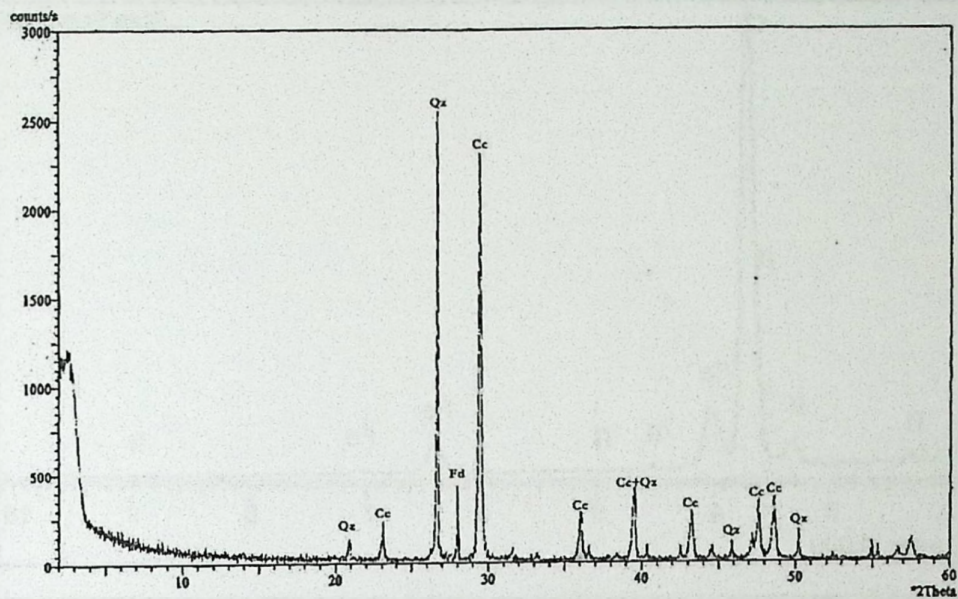
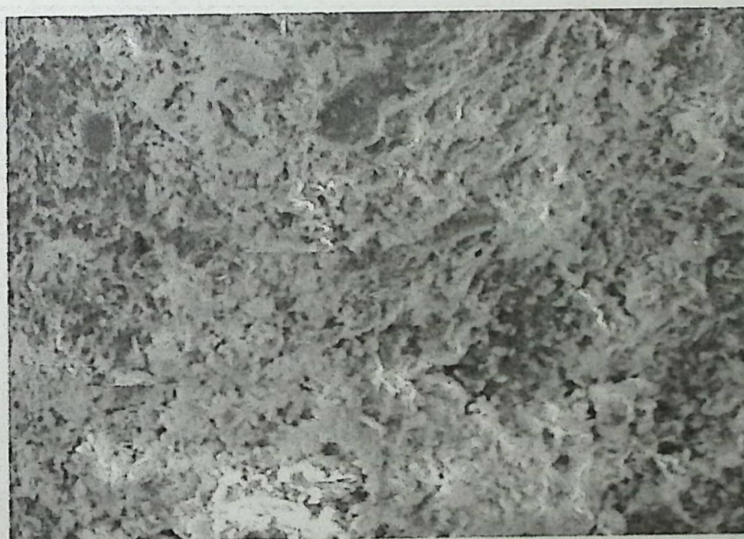
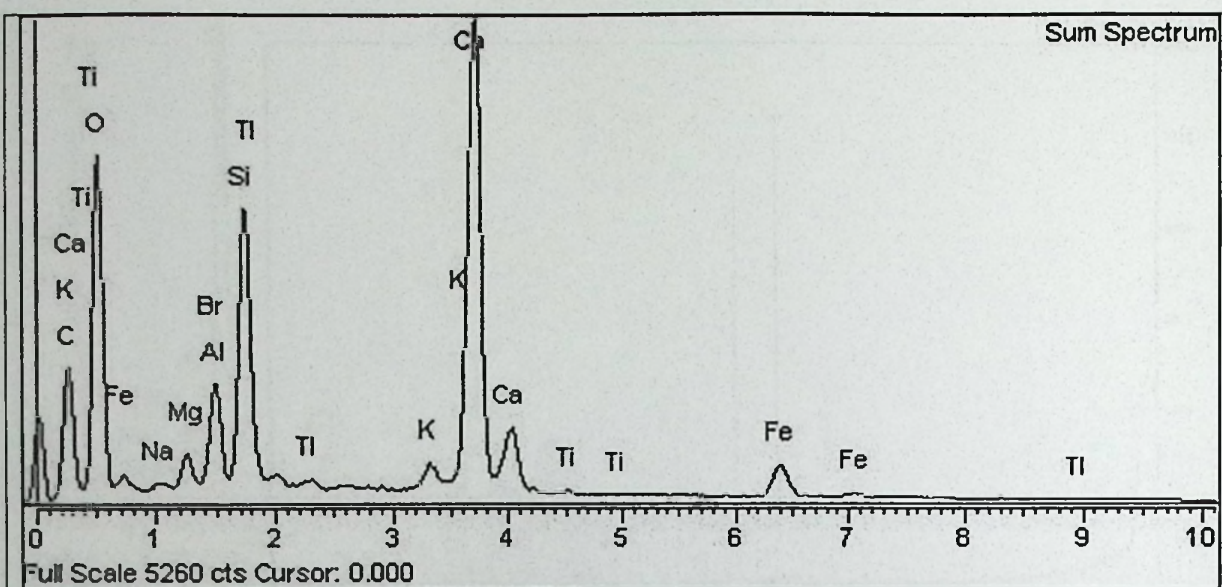
Sample 4 (stone masonry mortar).

Element	App	Intensity	Weight%	Weight%	Atomic %	Compd%	Formula	Number
	Conc.	Corrn.		Sigma				of ions
Al K	2.25	0.7443	2.80	0.55	2.65	5.30	Al ₂ O ₃	0.37
Br L	3.29	0.6941	4.41	1.09	1.41	0.00		0.20
Ca K	34.02	0.9956	31.75	0.47	20.19	44.42	CaO	2.81
Fe K	5.30	0.8295	5.94	0.18	2.71	7.64	FeO	0.38
K K	1.34	1.0783	1.16	0.06	0.75	1.39	K ₂ O	0.10
Mg K	1.35	0.6385	1.96	0.08	2.05	3.25	MgO	0.29
Na K	0.53	0.6562	0.76	0.09	0.84	1.02	Na ₂ O	0.12
Si K	11.79	0.7682	14.26	0.23	12.94	30.51	SiO ₂	1.80
Ti K	0.31	0.7557	0.38	0.07	0.20	0.63	TiO ₂	0.03
Ti M	1.06	0.7127	1.38	0.15	0.17	1.43	Ti ₂ O	0.02
O			35.21	0.59	56.09			7.80
Totals			100.00					
							Cation sum	5.91

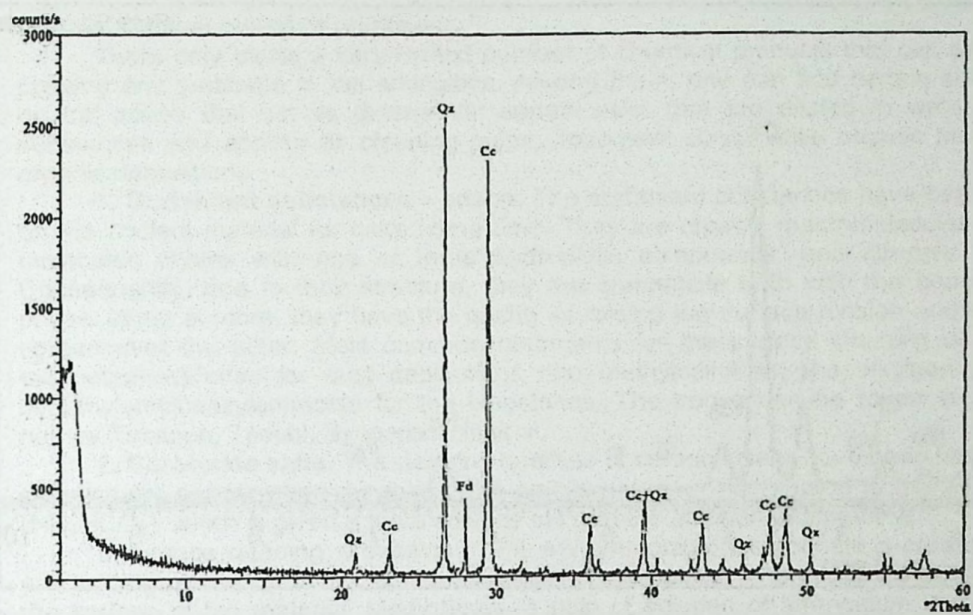
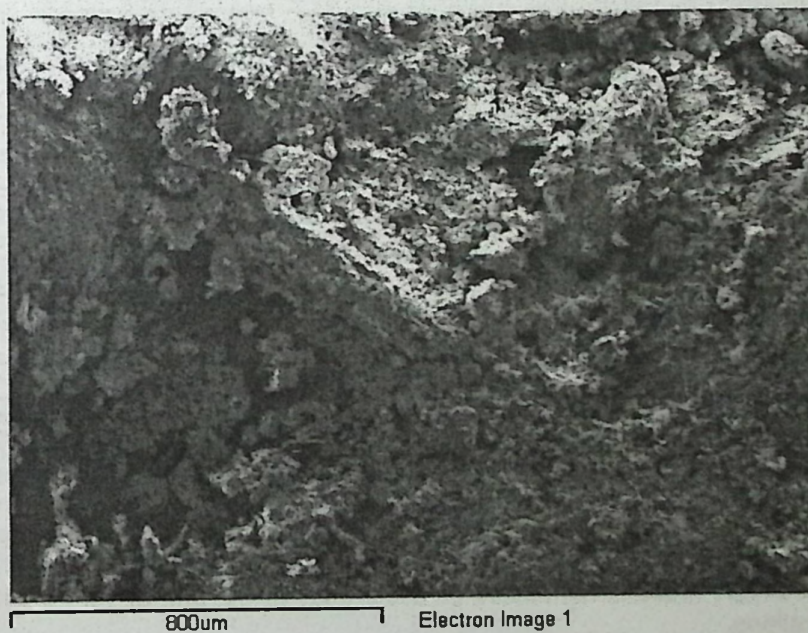
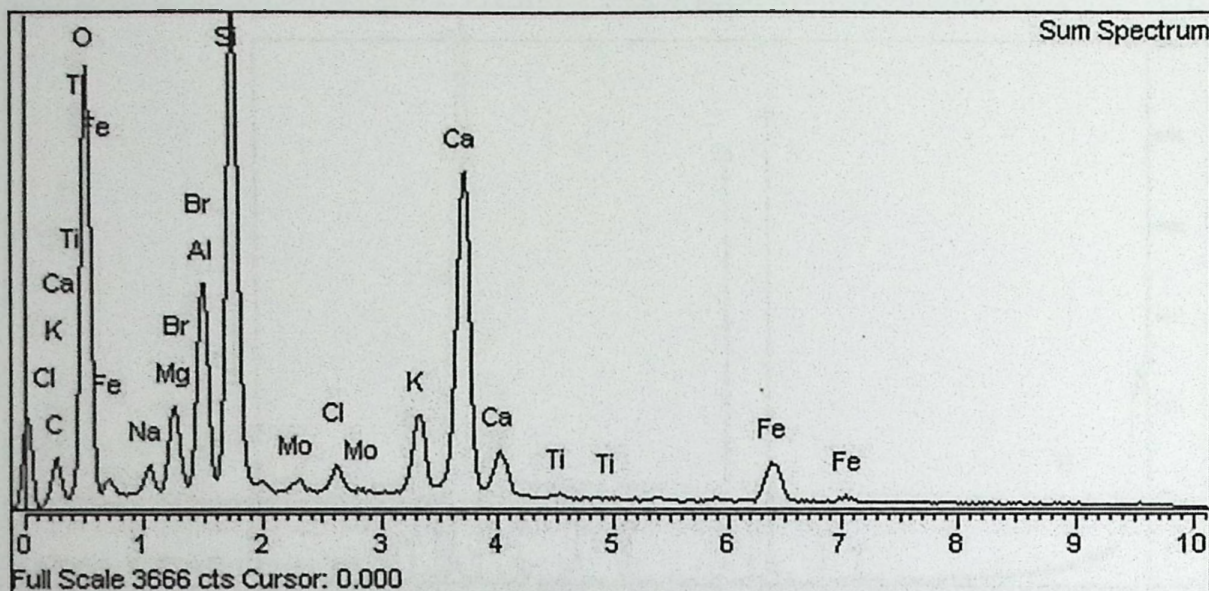
Sample 5 (stone masonry mortar).

Element	App	Intensity	Weight%	Weight%	Atomic %	Compd%	Formula	Number
	Conc.	Corrn.		Sigma				of ions
Al K	5.24	0.7545	5.35	0.61	4.72	10.11	Al ₂ O ₃	0.63
Br L	3.68	0.7033	4.02	1.23	1.20	0.00		0.16
Ca K	20.44	0.9533	16.50	0.29	9.81	23.09	CaO	1.32
Cl K	1.04	0.7113	1.13	0.06	0.76	0.00		0.10
Fe K	5.66	0.8336	5.23	0.17	2.23	6.72	FeO	0.30
K K	4.64	1.0155	3.52	0.09	2.14	4.23	K ₂ O	0.29
Mg K	3.17	0.6752	3.62	0.10	3.55	6.00	MgO	0.48
Mo L	1.13	0.6690	1.30	0.13	0.32	1.95	MoO ₃	0.04
Na K	1.41	0.7133	1.52	0.09	1.57	2.04	Na ₂ O	0.21
Si K	18.20	0.7491	18.71	0.32	15.87	40.02	SiO ₂	2.13
Ti K	0.41	0.7779	0.41	0.06	0.20	0.68	TiO ₂	0.03
O			38.70	0.69	57.63			7.74
Totals			100.00					
							Cation sum	5.43

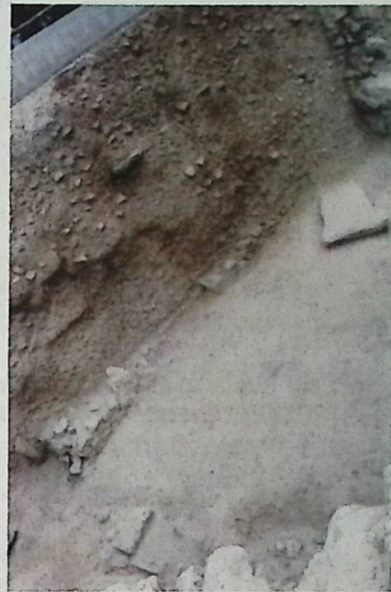
Fig. 8. Imitation of the sides of the archaeological site.

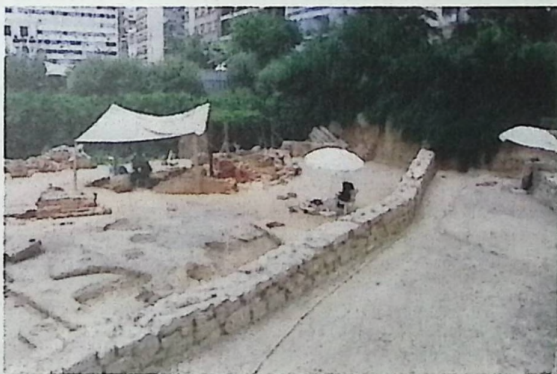
Fig. 9. The Acharnian Way after conservation.

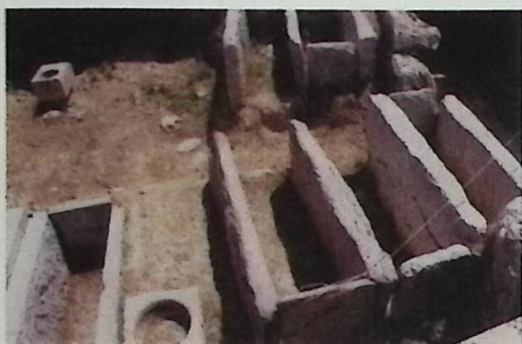
Fig. 13. The archaeological site after conservation.

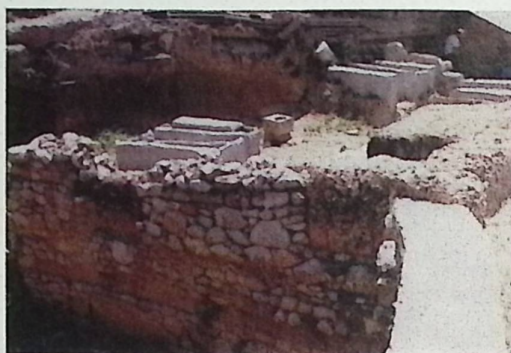
Fig. 14. The archaeological site after conservation.
